SUBARU

Legacy Sports Tourer 08/2009 >>
Outback 08/2009 >> 02/2015

Part No: SB-050-13U

Electric wiring kit for towbars / 13-pin / 12 Volt / ISO 11446 Fitting instructions

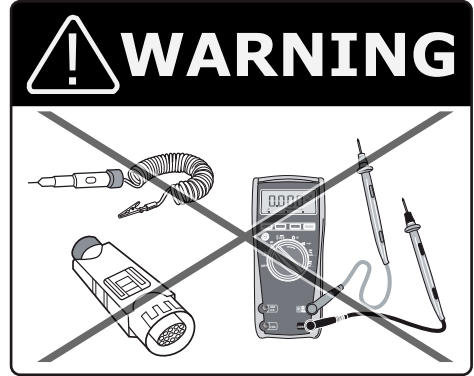
25

Functional test

LIGHTMATE

ECS part no.
LIGHTMATE II
LIGHTMATE III
